## **SITE INVESTIGATION AND GEOTECHNICAL FAILURES**

Za-Chieh Moh

*Moh and Associates Group*

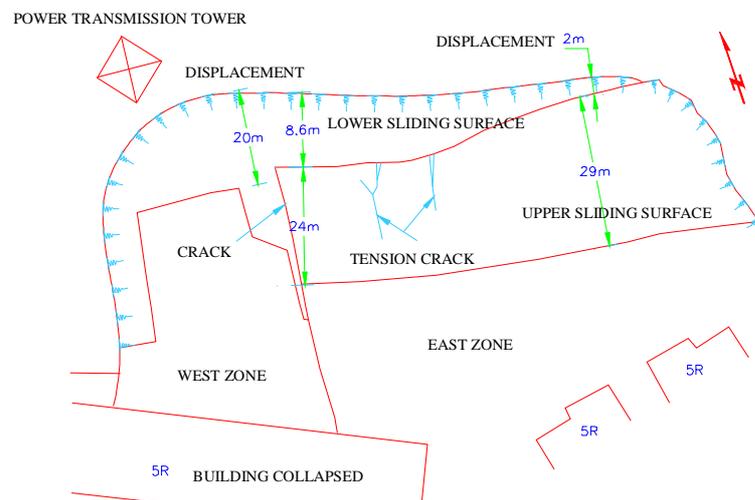
Fig.1 Extent of Landslide and Displacement, Case One

The sliding area was rectangular in shape, about 140m in the E-W direction and 50m in the S-N direction. Figure 1 shows the extent of the landslide, displacement and distribution of tension cracks.

- (1) Inaccurate site investigation report – The site investigation report did not indicate the presence of shale.
- (2) Improper selection of geotechnical design parameters – The design did not give due considerations of effect of groundwater.
- (3) Poor construction quality – Construction of the retaining structure was not properly supervised by qualified person for quality as well as quantity control.

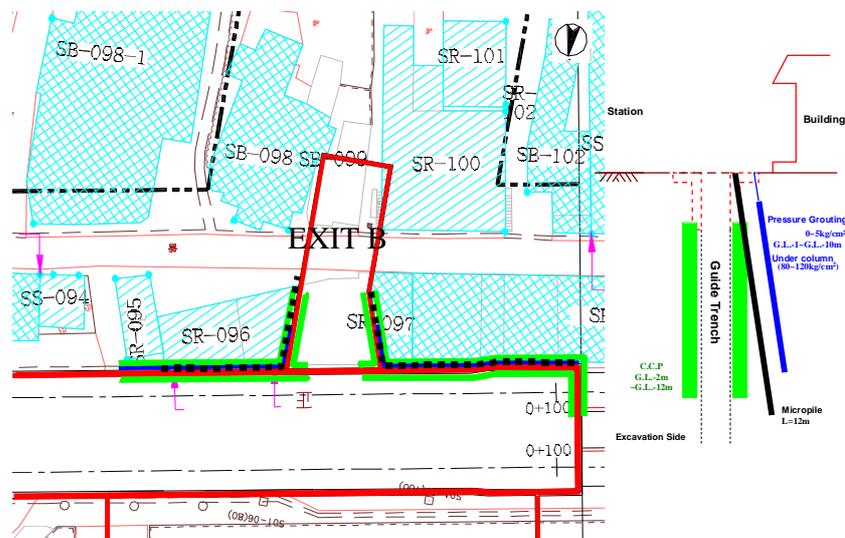
Fig. 2 Location Plan of Fu-Ta Station, Case Two

The case is the construction of one of the underground stations of the Taipei Mass Rapid Transit Systems. Excessive settlements and tilting of adjacent structures occurred during construction of the guide trench of the diaphragm wall for one of the station exit. As shown in Figs. 2&3, there are two 3-storey building, i.e. SR-096 and SR-097, located immediately adjacent to the station Exit B. These two buildings were founded on R.C. spread footings. In view of the fragile nature of the structure and foundation, micropiles were installed to reinforce the building support and pressure grouting were made on both sides of the guide trench to a depth of about G.L.-12m prior to the excavation work.

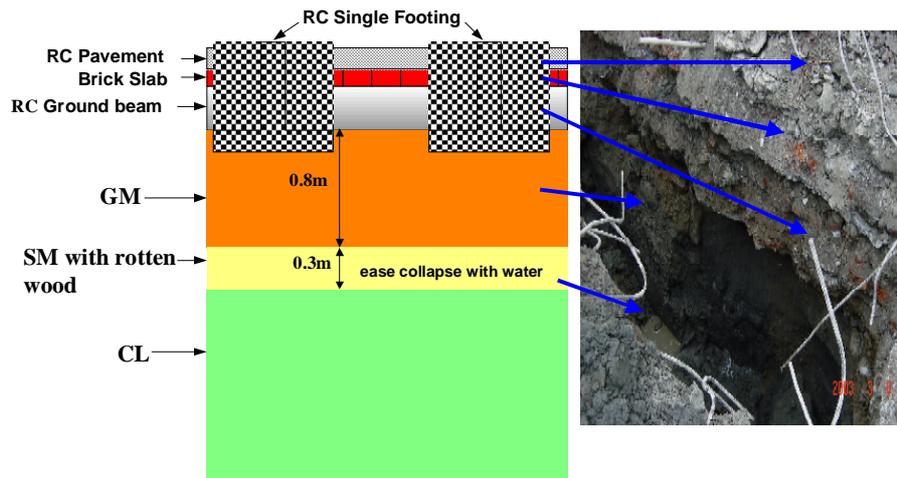
Fig. 4 Subsurface Condition Below Building SR-097, Case Two

During test excavation of the area after demolishing of the tilted buildings, it was found that there was a thin layer (about 30cm) of sandy soil containing decayed woods within the upper sandy soil stratum as shown in Fig. 4. This compressible soil was not discovered during the site investigation even if the number of boreholes drilled was in accordance to the code requirement. However, if information were gathered from neighboring occupants during the SI work, continuous sampling of the upper subsoil payer would certainly reveal the existence of such unfavorable subsoil condition.

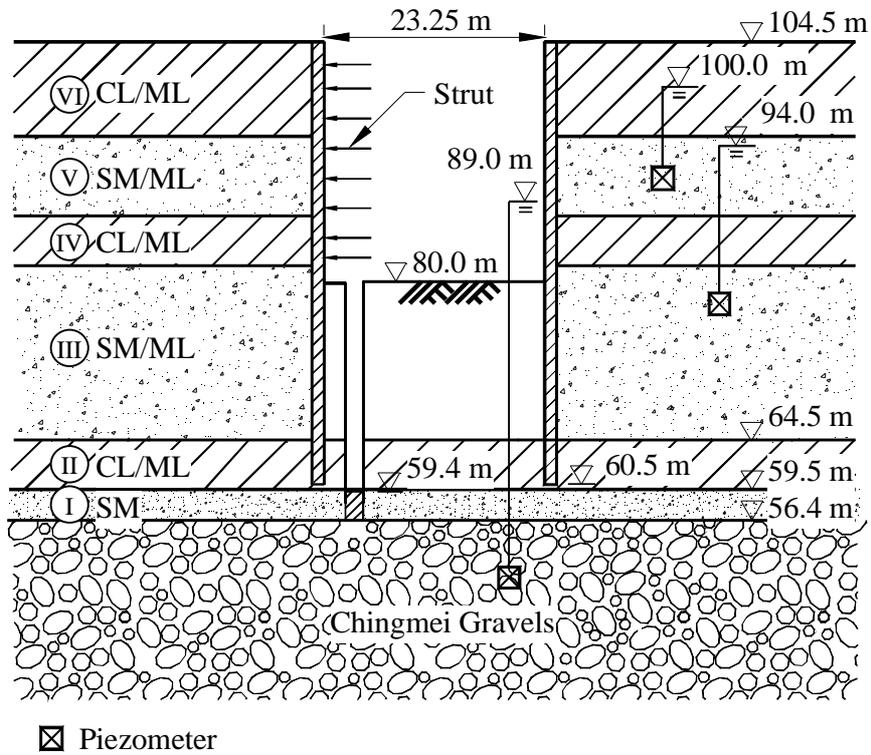
Fig. 5 Soil profile and configuration of excavation

The excavation of interest was for construction of an underground station of the Taipei Rapid Transit Systems. It is located in central Taipei City. The subsoil distribution is typical of that in the Taipei Basin (Moh and Ou, 1979), with a thick layer of young sediments i.e. the so-called Sungshan Formation from the ground surface to a depth of about 48. The Sungshan Formation comprises 6 alternative layers of silty sands (SM/ML) and silty clays (CL/ML). Underneath the Sungshan Formation is a highly permeable gravel layer, i.e. the so-called Chingmei Gravels. This gravel layer was in artesian condition decades ago and the piezometric level in this layer had dropped to as low as RL 60m as result of excessive pumping before the 70's. The clayey sublayers in the Sungshan Formation are relatively impermeable and separate the entire subsurface soil stratum into three aquifers with different piezometric levels. The piezometric levels in the Sungshan Formation responded to the lowering and rising of the pressure heads in the Chingmei Gravels, there obviously are flows across neighboring aquifers. A typical subsoil profile is shown in Fig. 5.

As shown in Figs. 5 and 6, the excavation was 23m in width and was carried out to a depth of 24.5m by using the bottom-up method. The pit was retained by diaphragm walls, 1.2m in thickness and 44m in length, and braced by 8 levels of temporary struts. The diaphragm walls toed in Sublayer II to provide a seepage cutoff. Sublayer II, which is an impervious layer consisting mainly of silty clay, essentially served as a seal at the bottom of soil plug which was enclosed by diaphragm walls on its four sides. With a length of soil plug of 20.5m, a factor of safety of 1.3 was obtained against blow-in for a piezometric head of 29.5m at the bottom of the plug. At the time when the incident occurred, the bottom of excavation had been reached and, except at the southern end where the incident occurred, base slab had already been cast.

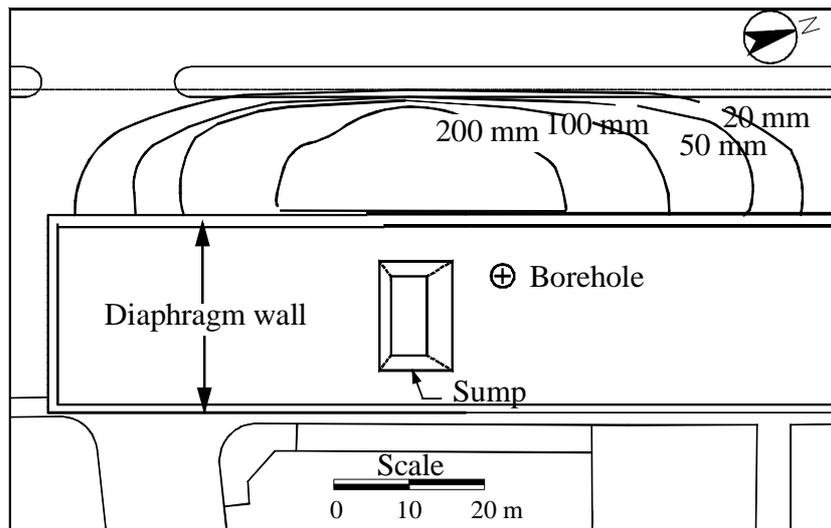
Fig. 6 Borehole, sump and settlement contour

The excavation was well instrumented with settlement markers, inclinometers, load cells, etc. Because blow-in was one of the major concerns, the piezometric levels in the Sungshan Formation and the Chingmei Gravels were closely monitored. One of the piezometers became faulty and the contractor attempted to replace it by a new one. At that time, the excavation at the southern end had already been completed and the bottom of excavation was protected by a layer of plain concrete. Drilling was carried out from the bottom of excavation at the location shown in Fig. 2. As drilling reached RL 59.4m, refer to Fig. 1, water started to overflow from the borehole.

Although various means have been tried, including extension of drilling casing, placing of sand bags on top of the borehole, grouting etc., the flow soon became uncontrollable and the pit had to be flooded to prevent the situation from deteriorating. As much as 70,000 tons of water was recharged to balance the hydrostatic pressure from the groundwater. It took 6 months to mend the damaged clay blanket under the bottom of excavation before the pit was drained and the works resumed. A total of about 3,000 cu m of LW (Labile Wasserglas) grout consisting of cement, sodium silicate and water and about 2,400 cu m of cement-bentonite grout was injected into the ground to fill up cavities made by the seepage flow. Figure 6 shows the settlement contour of the surrounding area. Effect of the incident extended to a distance more than 60m from the location of the borehole. Maximum ground settlement exceeded 250mm.
